Technical Report

Roof light Test

Project Ref. 11574

Product Tested: Glass roof light and associated support

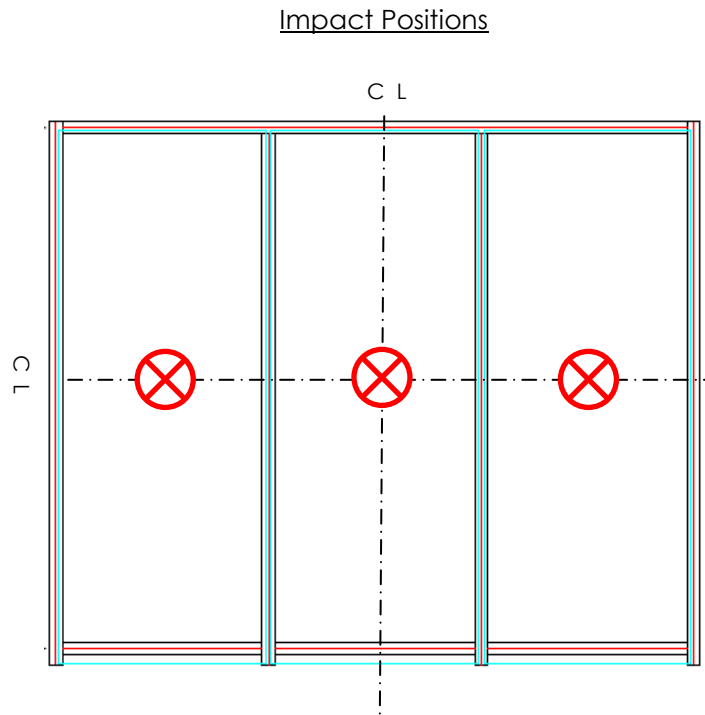
Figure 1

- Impact position

Not to scale

The soft body impactor was dropped under gravity to impact the centre of the test panel from 1200 mm. The panel was then inspected for damage.

The hard body impactor was dropped under gravity to impact the centre of the test panel from 1200 mm. The panel was then inspected for damage.

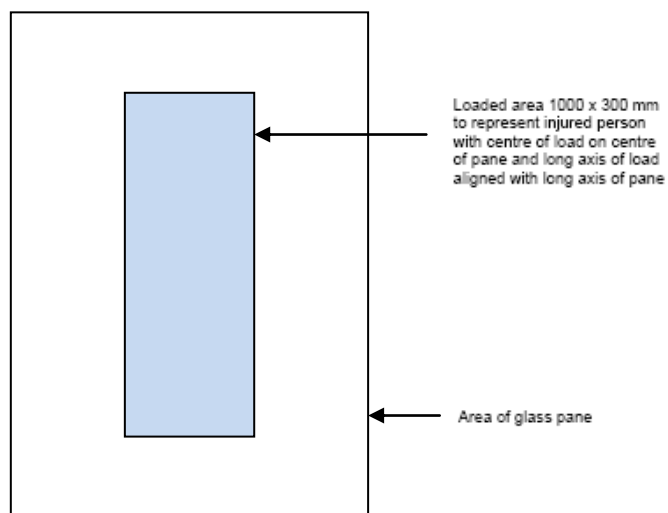
Retention of Static Load Application

A static load of **90 kg** was applied to the broken glazing. This consisted of 2 x soft body impactors (each weighing 45 kg). The sand bags were placed onto the sample as shown in both Figure 2 and Photo. 1. Once the full load had been applied, it was required to remain in place for a minimum of **30 minutes**.

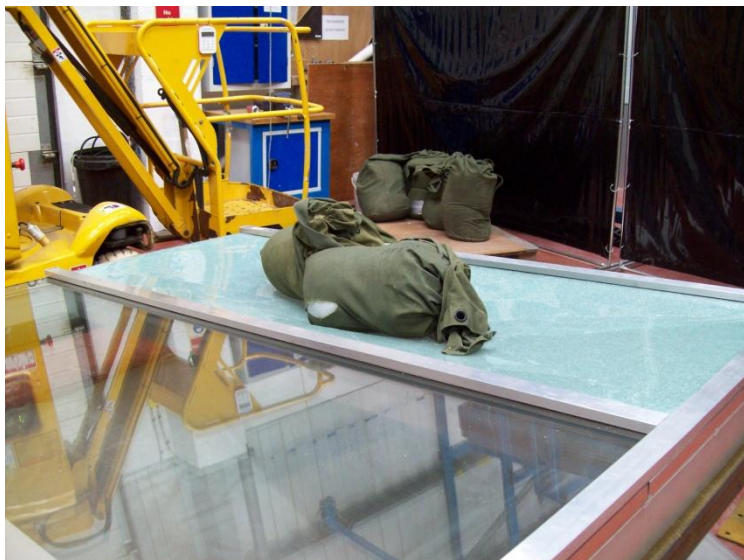
Photograph no. 1

Photo shows the 90Kg static load applied

Test Panel A1 – The load remained in place throughout the required time with no further damage to the inner pane observed.

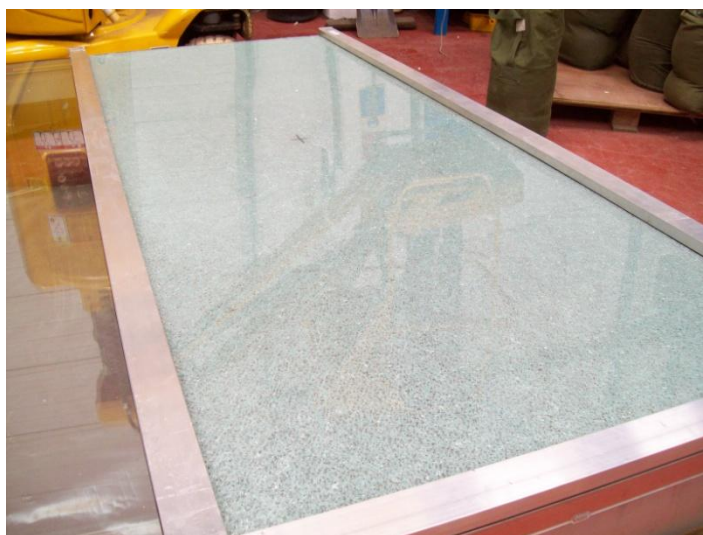
Photograph no. 2

Outer pane has been broken to enable testing to be conducted on the inner pane

PLEASE NOTE: It was necessary to manually break the outer pane after these tests. Afterwards the inner pane was inspected to see that no damage was caused following this action, and this was found to be the case.

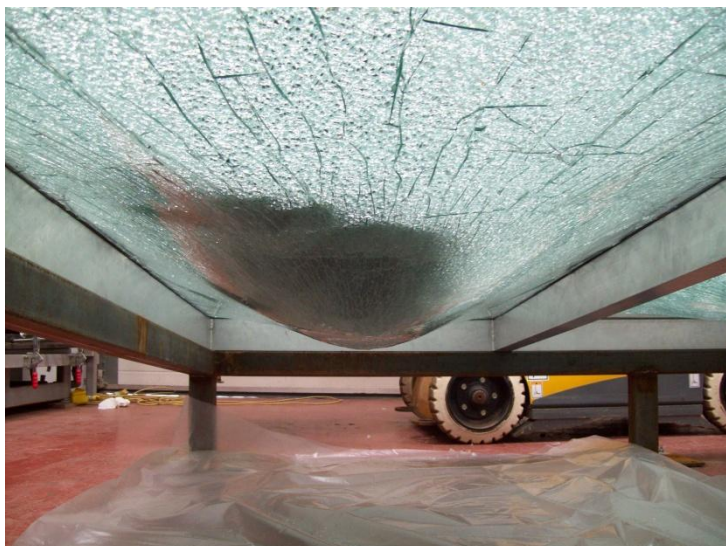
Photograph no. 3

Underside of sample under static load (90kg)
